Bulletin Number: GMBTB-071519

Date: July 15,2019
Product: Steam Boilers
From: Technical Support
Title: Heat Exchanger Failures and Maintaining Steam Boilers

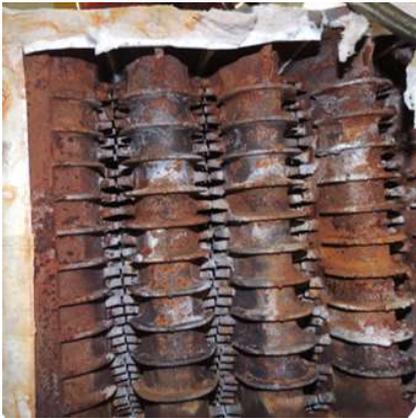
Overheating

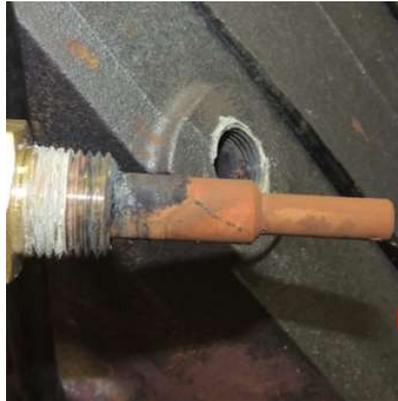
LWCO Probe fouled

Bringing in makeup water creates two issues. The first is oxygen. Oxygen is entrained in the water and when heated in contact with the cast iron heat exchanger, attacks the metal at and above the waterline. All water also has other impurities in it including dissolved minerals, metals, etc. As the makeup water is brought into the boiler so are these additional impurities. As the water steams, these impurities are left behind in the heat exchanger and form a coating on all the internal surfaces, including the LWCO probe. The coating reduces efficiency because the heat exchanger is now “insulated”. As the heat exchanger gets more and more insulated the temperature of the heat exchanger keeps rising until it reaches the failure point. If the LWCO probe becomes coated it will fail to function properly. The tip of the probe must be able to sense an electrical signal to work properly.

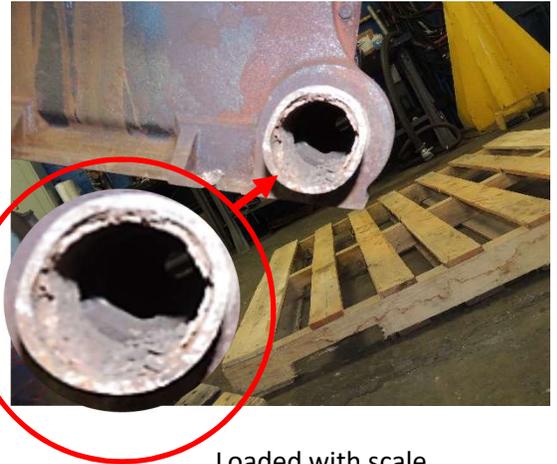
Loaded with scale

Failures caused by scale build up are due to neglect and not considered to be manufacturing defects. They are not covered by the warranty.

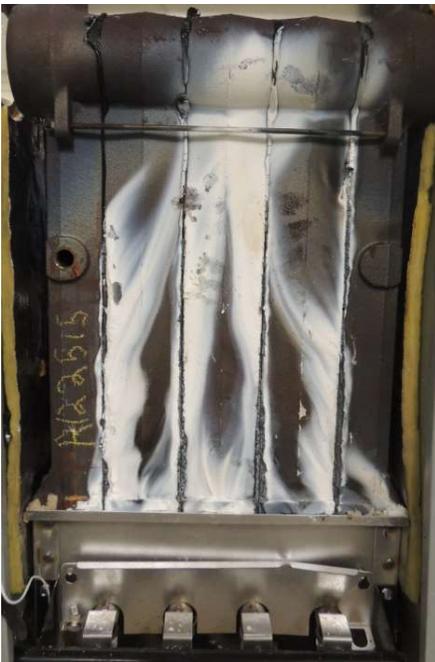
Overheating

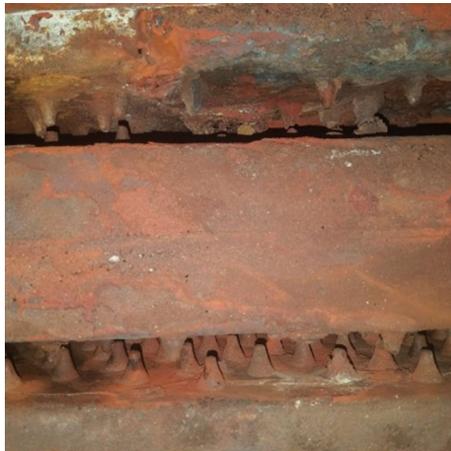
Corrosion above the waterline

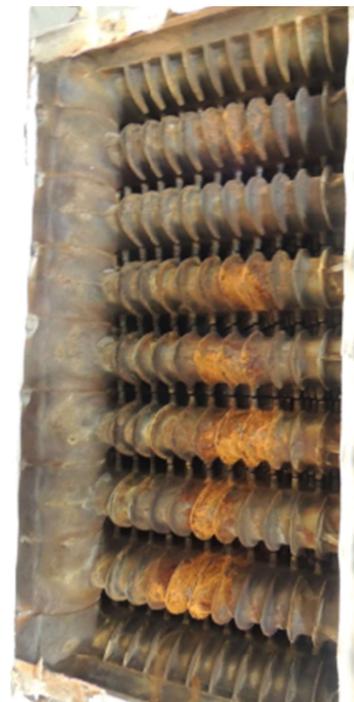
Multiple sections fractured
